ZU1 Power Table

PROJECT : ZU1 Quanta Computer Inc.</div>		PROJECT : ZU1	APPROVE BY : James Lu	DRAWING BY:Barry Lee	Stage: A1	CHANGE LIST SHEET 1
		MB ASSY'S P/N : 31ZU1MB0000	PROJECT LEADER:Jack Wu	DOCUMENT NO:	DATE :2006/12/09

# ZU1 SYSTEM BLOCK DIAGRAM

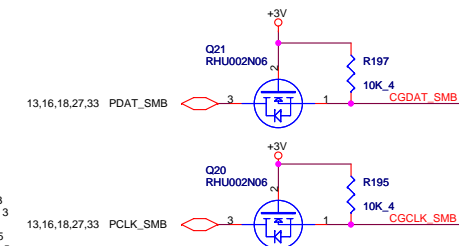
## Clock Gen I2C

Pin	Active	Control signal
32	Low	SRC9/9#
33	Low	SRC10/10#

A1A: (9/24) Base on above table, SWAP SRC3 and SRC9

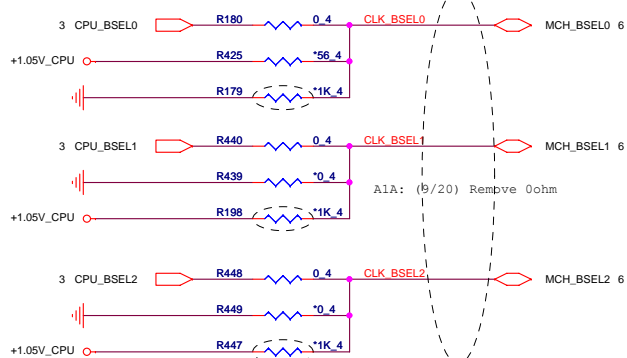
## CPU Clock select

C2A: (12/10) no stuff R179,R198,R447 for auto CPU frequency selection (follow ZD1,Z01)

Item:	Fixed Issue	Modify List:	Schematic Rev.	Page		
1	CPU Clock select issue	Stuff R179,R198,R447 for CPU Clock select issue	A1A	2		
2	PCI Clock issue	change R186 value from 33ohm to 22 ohm (refer to Intel check list 1.301)	A1A	2		
3	CK505 issue	ICS FAE suggest to change C542,C287 from 4.7u to 10u	A1A	2		
4	EMI issue	EMI suggest to reserve R436,R199,R444 for EMI test	A1A	2		
5	CK505 issue	Add PCIE_CLKREQ# PU to +3v	A1A	2		
6	CK505 issue	SWAP SRC3 and SRC9	A1A	2		
7	CK505 issue	Add PCIE_CLKREQ# PU to +3v	A1A	2		
8	CK505 issue	Remove U19/Pin48 (no use)	A1A	2		
9	CK505 issue	Add PCIE_CLKREQ# PU to +3v	A1A	2		
10	CK505 issue	remove SATACLKREQ function, change R188 value from 475ohm to 22 ohm	A1A	2		
11	CK505 issue	FAE : (14M_ICH and SIO_14M) signals trace should be equal length	A1A	3		
12	CPU issue	Remove XDP/ITP signals (no use)	A1A	3		
13	CPU issue	Retain the termination resistors (R157,R150~R152) on these signals even when ITP700 not implemented.	A1A	3

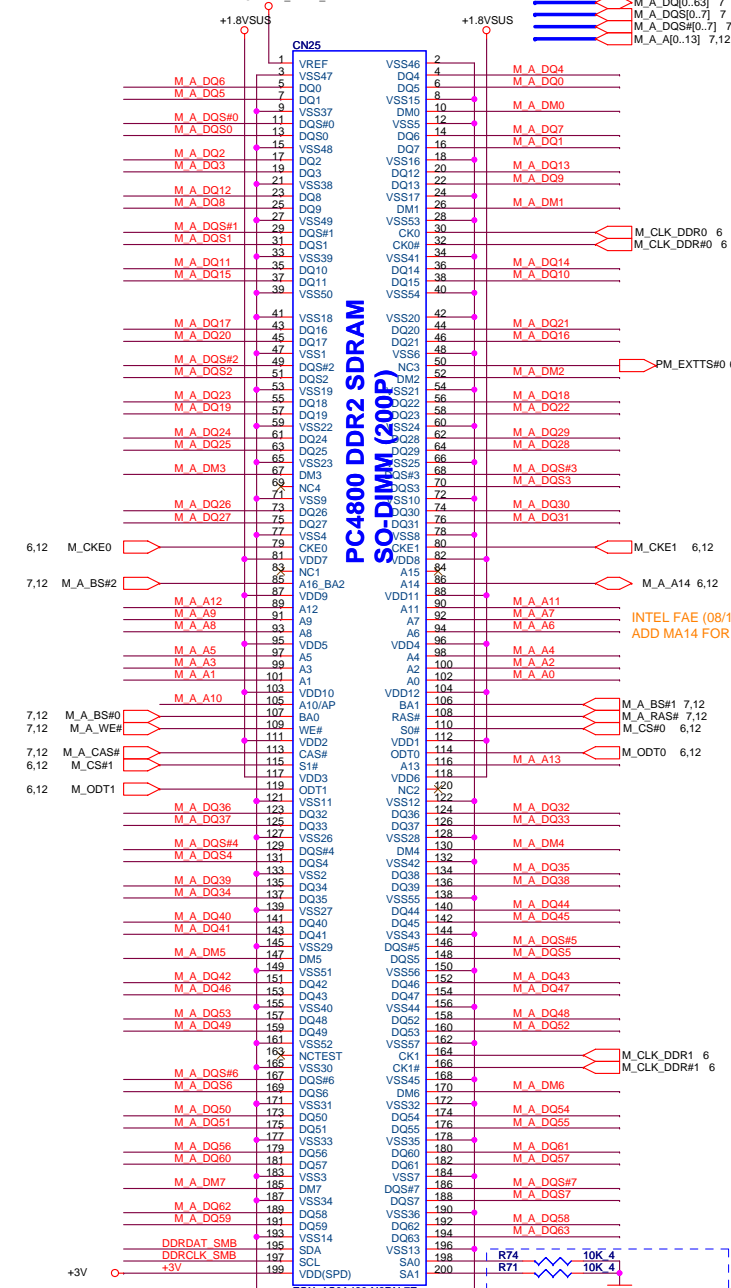
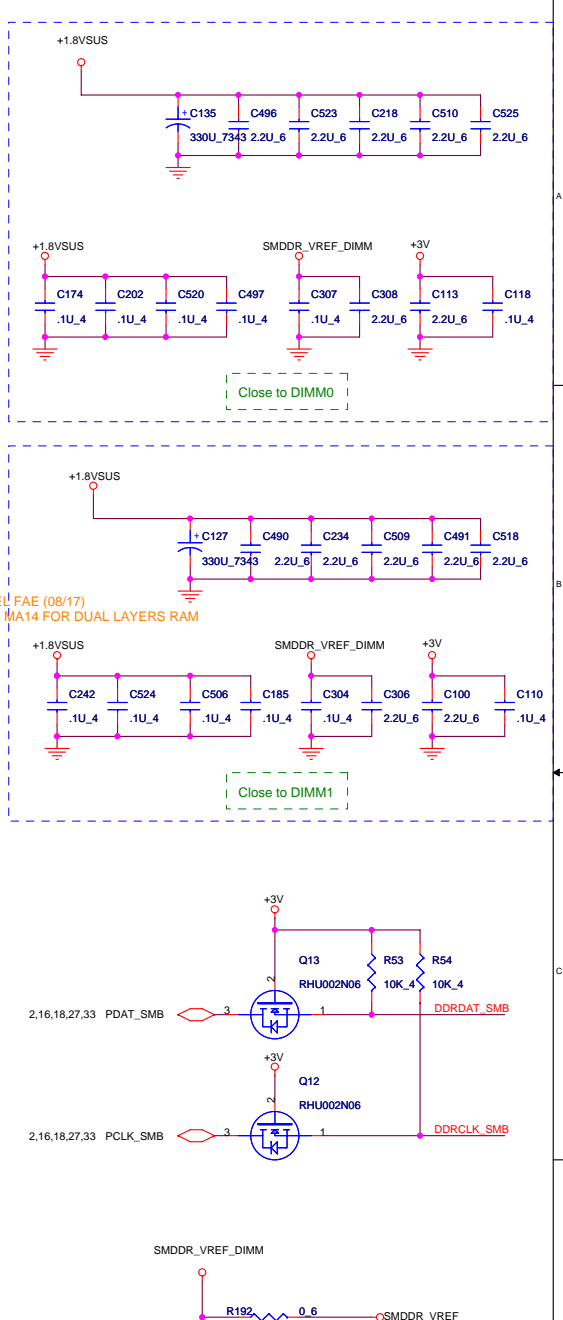
DDR2 Dual channel A/B CONN

H: 5.2mm

CLOCK 0,1  
CKE 0,1

H: 9.2mm

CLOCK 3,4  
CKE 2,3

A1A: (10/30) no stuff R192, stuff R191,R193  
A1A: (11/09) stuff R192, no stuff R191,R193

14	Thermal Trip issue	change Q19/Pin3 net name from THERM_SYS_PWR to SYS_SHDN#	A1A	3		
15	CPU FAN issue	change CPU FAN CONN (follow ZC3)	A1A	3		
16	CPU FAN issue	Add CPUFAN#_ON to (U28/PIN1)	A1A	3		
17	CPU FAN issue	Add Diode D39 and PU +5V for (U28/Pin1)	A1A	3		
18	CPU Thermal monitor issue	Add (U27/Pin6) PU to 3V	A1A	3		
19	CPU Thermal monitor issue	remove R389, already PU in ICH8	A1A	3		
20	CPU Thermal monitor issue	change SMBUS from MBCLK/MNDATA to 2ND_MBCLK/2ND_MBDATA (Q30,Q31)	A1A	3		
21	CPU Power issue	stuff C198, unstuff C217 (base on layout location)	A1A	4		
22	GMCH Power issue	Short R115~R117,change +VCC_CFXCORE_INT to +1.05V	A1A	8		
23	GMCH Power issue	Short R122,R138, remove VCC_RXR_DMI circuit (connect to +VCC_PEG directly)	A1A	9		
24	GMCH Power issue	INTEL CRB VCCD_QDAC Filter Modification:change L13 to R125(100ohm), change R145(*0 ohm) to C507(1uF)	A1A	9		
25	DDR Power issue	stuff R192, no stuff R191,R193 for SMDDR_VREF_DIMM	A1A	13

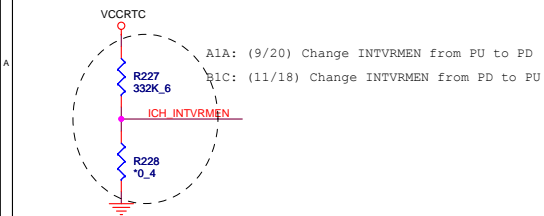
**ICH8-M Internal VR Enable strap**  
(Internal VR for Vccsus1\_05,VccSus1\_5 and VccCL1\_5)

INTVRMEN	Low = Internal VR disable High = Internal VR enable(Default)
----------	---

97	ICH8-M Strap issue	Change INTVRMEN from PD to PU			B1C	14
98	Leakage issue	add D43,D44 to stop leakage from EC to SB			B1C	16
99	ICH8-M issue	change DOCKIN# from GPIO7 to GPIO12			B1C	16
100	Power sequence issue	short PWROK_EC to MPWROK			B1C	16
101	ICH8-M issue	PU GPIO10 to +3V, PD GPIO14 to GND			B1C	16
102	ICH8-M issue	remove R229,R233,C355			B1C	16

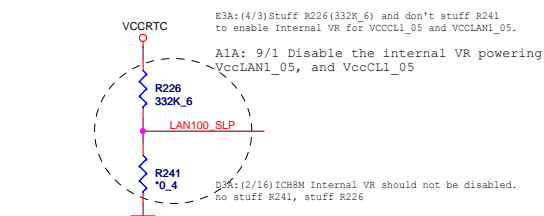
**ICH8-M LAN100\_SLP Strap**  
(Internal VR for VccLAN1\_05 and VccCL1.05)

LAN100_SLP	Low = Internal VR disable High = Internal VR enable(Default)
------------	---

26	RTC BAT issue	Change RTC BATTERY CONN CN12(follow to ZC3)	A1A	14		
27	ICH8-M Strap issue	Stuff R241, no stuff R266 (Disable Internal VR powering VccLAN1_05, VccCL1_05)	A1A	14		
28	ICH8-M HDA issue	add R283,R465,R463,R267 for MDC module (base on Intel Design Giude)	A1A	14		
29	ICH8-M issue	PU RCIN# to +3V	A1A	14		
30	ICH8-M issue	Remove ICH8-M GLAN/SATA1/SATA2 circuit (no use)	A1A	14		
31	ICH8-M issue	change net name (U31/Pin2) from VR_PWRGD_CLKEN# to VR_PWRGD_CK410#	A1A	16		
32	ICH8-M issue	Remove SATACLKREQ#(U32/Pin:AG13),RI# (U32/Pin:AF17) ;{no use}	A1A	16		
33	ICH8-M issue	no support iAMT, remove SMB_CLK_ME,SMB_DATA_ME	A1A	16		
34	ICH8-M issue	change DOCKIN#_ICH_R PU from +3V to +3V_S5	A1A	16		
<div>

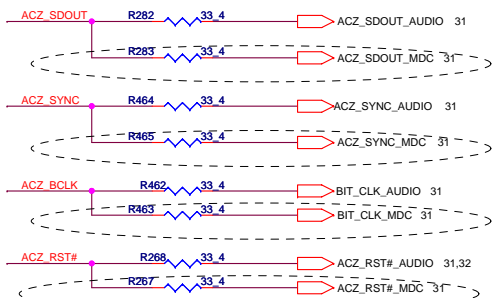
## HDA

AlA: 9/6 base on Intel design guide, add it.

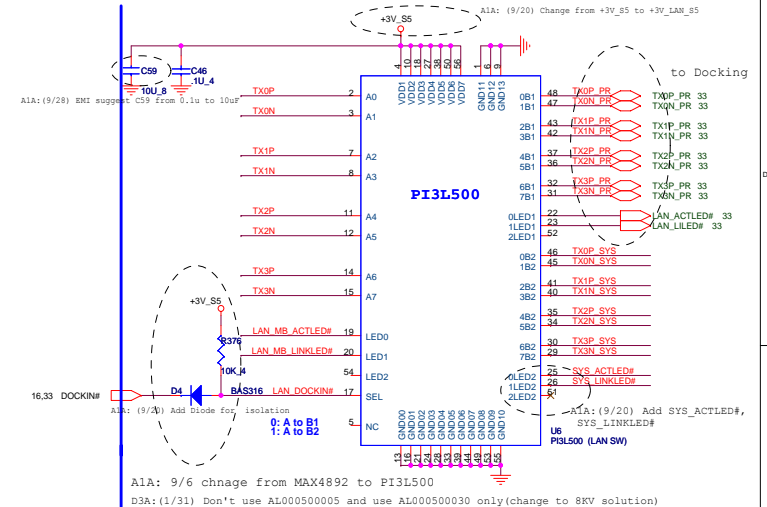
AlA: 9/6 chnage from MAX4892 to PI3L500

D3A:(1/31) Don't use AL000500005 and use AL000500030 only(change to 8KV solution)

157	CableSence circuit issue	change LAN Low power pin from GPIO47 to GPIO52	D3A	28		
158	LAN switch issue	Change U6 from AL000500005 to AL000500030 (change to 8KV solution)	D3A	18		
159	Change 965GM from ES sample to QS sample	Change U29 P/N from AJ0QN120T37 to AJ0QP200T09	D3A	5~11		
160	Change ICH8M from ES sample to QS sample	Change U32 from AJ0QM740T31 to AJ0QN230T10	D3A	14~17		
161	Audio Jack issue	change CN30,CN31,CN32 footprint from AUDIO-010164FR006GX53XL-C-8P to AUDIO-JA60331-X39T4-7F-8P	D3A	32		
162	docking sometimes can't detect DVI device issue	change R51,R56 from 3.9k(CS23902FB14) to 4.7k(CS24702JB38).	D3A	21		
163	EMI issue	EMI suggest, add common Choke, co-lay R795,R796	D3A	27		
164	Audio Jack issue	Change CN30 P/N from DFTJ06FR017 to DFTJ06FR059	D3A	32		
165	Audio Jack issue	Change CN29 P/N from DFTJ06FR019 to DFTJ06FR061	D3A	32		
166	Audio Jack issue	Change CN31 P/N from DFTJ06FR018 to DFTJ06FR060	D3A	32

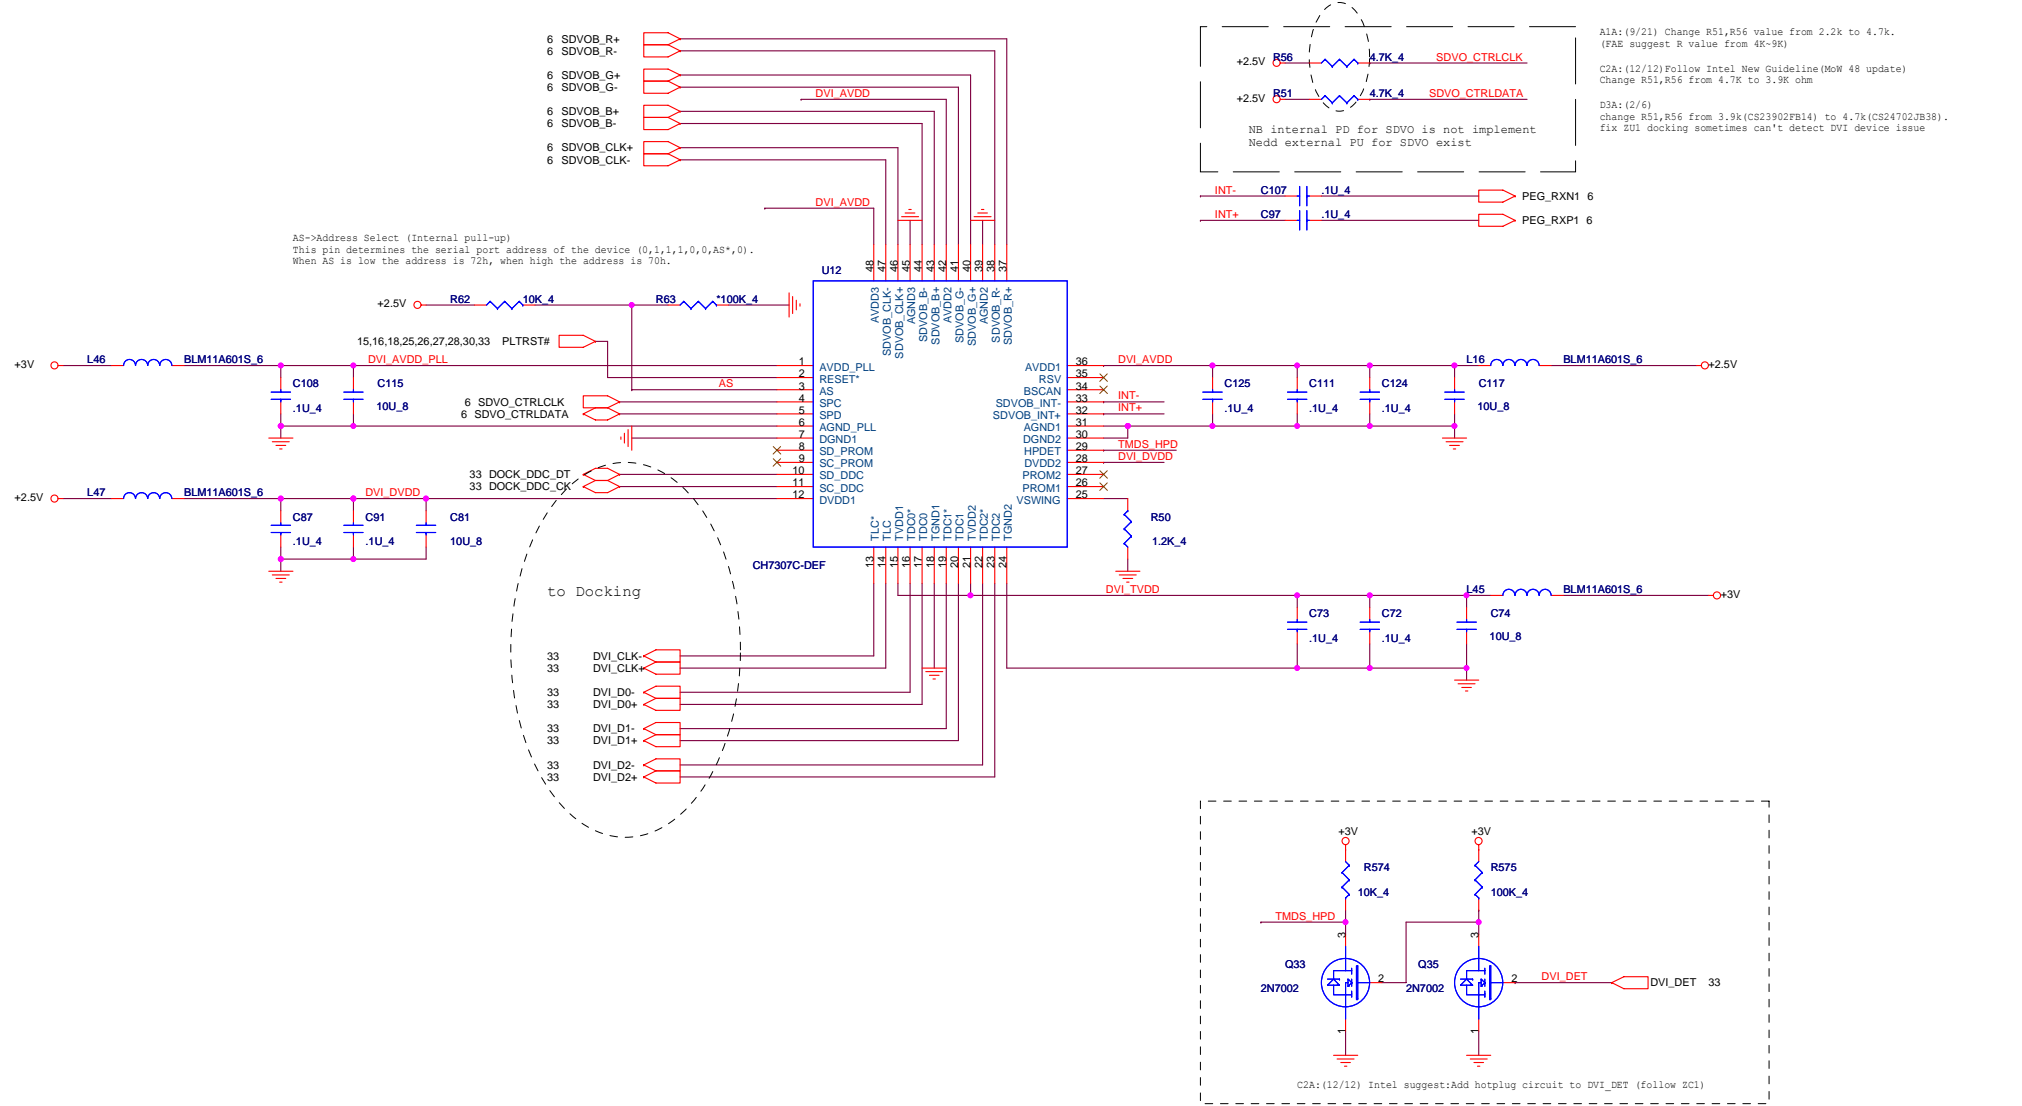
A1A: (9/21) Change R51,R56 value from 2.2k to 4.7k.  
(FAE suggest R value from 4K-9K)  
C2A: (12/12) Follow Intel New Guideline (MoW 48 update)  
Change R51,R56 from 4.7K to 3.9K ohm  
D3A: (2/6)  
change R51,R56 from 3.9k(CS23902FB14) to 4.7k(CS24702JB38).  
fix ZUI docking sometimes can't detect DVI device issue

D3A: (1/30) remove U13,R68,R75,R73,C98  
1/16 confirm with CHRONTEL FAE,  
he said we can remove CH9901 (U13),  
if ZUI need support HDCP,  
CH7313 already integrated HDCP function, no need external EEPROM.

C2A: (12/22) confirm with FAE ->  
Due to Intel VBIOS already integrate the EEPROM function.  
ZUI will remove the U11,R57,R52,C109 to save layout space.

59	LVDS issue	Change C12 from CH6102M9900 to CH61004M3E5 (refer to ZC3)	A1A	20		
60	TV issue	Change CN17 CONN P/N (follow ZC1)	A1A	20		
61	SDVO issue	Change R51,R56 value from 2.2k to 4.7k (FAE suggest R value from 4K~9K)	A1A	21		
62	PCMCIA issue	refer to BL3. Add G_RST# circuit.	A1A	22		
63	PCMCIA issue	FAE suggest R189's value under 47 ohm.	A1A	22		
64	Card reader issue	no stuff R496,R522	A1A	23		
65	Card reader issue	FAE suggest R503's value under 47 ohm.	A1A	23		
66	Card reader issue	Remove U39/Pin99, no use (XMDAT4B is for 8 bit MMC,remove it.)	A1A	23		
67	Card reader issue	Change C593 from 0.1u to 10uF,EMI suggest add C587 0.1uF	A1A	24		
68	PCMCIA issue	change PCMCIA CONN (follow BH1)	A1A	24		
<div>

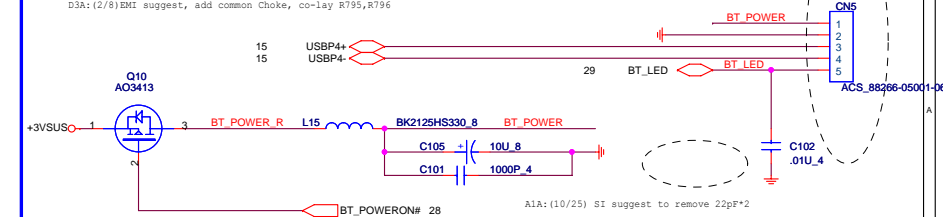
## BLUETOOTH MODULE CONNECTOR

A1A: (9/25) change CONN (follow ZH3)

D3A:(2/8)EMI suggest, add common Choke, co-lay R795,R796

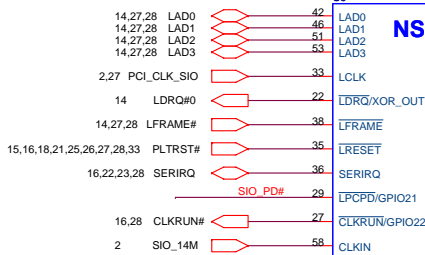
# NS SIO PC87383

AlA: (9/20) PPT PU 4.7k circuit exist in Docking. remove it.

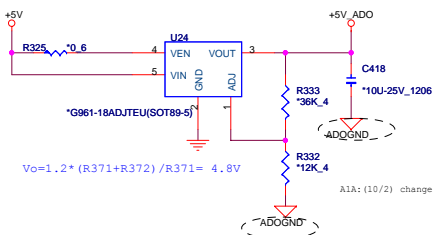
Tied at one point only  
under the codec or  
near the codec

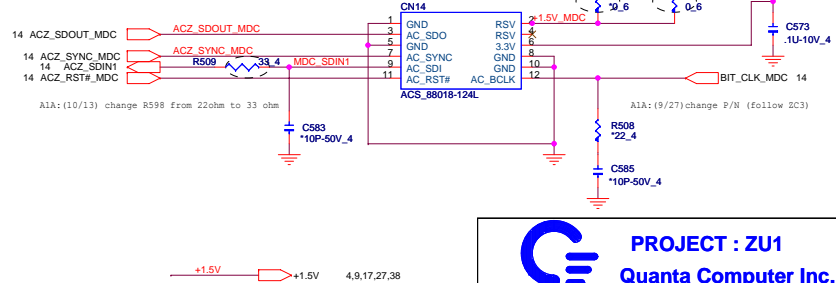
## MDC

D3A:(1/21) Change CN14/pin 2 from +3v to +3v\_s5.  
Fix Modem wake from S3 fail issue.
