Compal Confidential

INTEL Auburndale BGA with IBEX core logic

Swatch UMA

LA-5251P

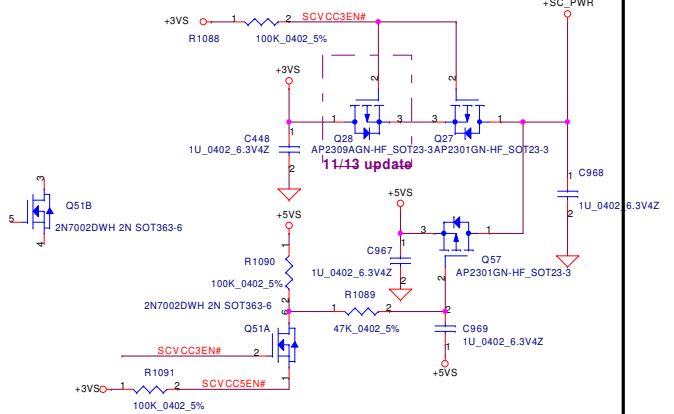
04/23 Add Q28 to prevent +5VS from leaking through Q27.

0.7	20	11/13	CKT,BOM,Layout	32	-M/E Screw hole size modify. <Compal/HP>.	--Change H2 from H_4P4 to H_4P7; H28 from H_4P8 to H_4P9.
0.7	21	11/13	CKT,BOM	25	-To fix CBB auto active caused by +3VS leakage issue. <Compal>.	--Change Q28 from AP2301(SB000007H10) to AP2309(SB00000MI00).

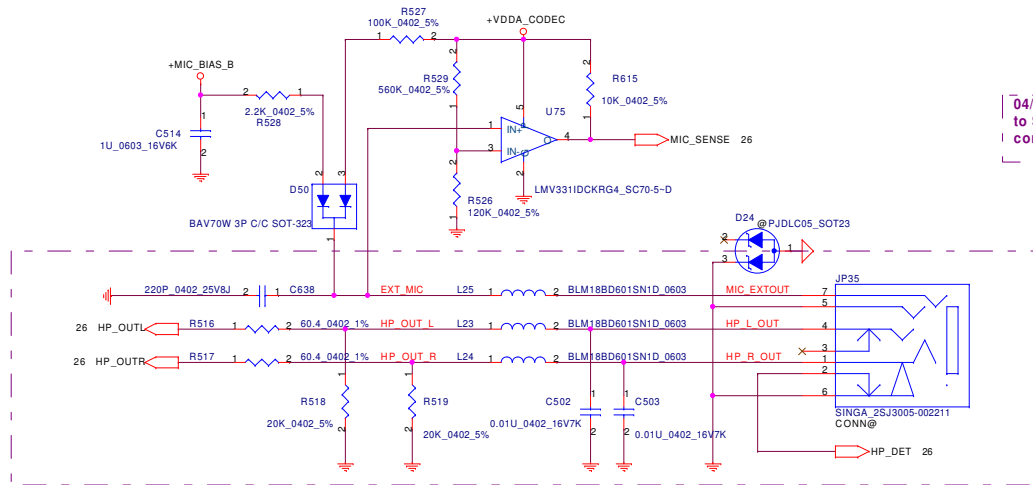
04/24 Correct the Symbol from SINGA_2SJ-B960-003 to SINGA_2SJ3005-002211, also correct the connection for fix Audio work abnormal issue.

Old	New
1HP_L_OUT	1HP_R_OUT
2HP_R_OUT	2HP_DET
3GNDA	3DUMMY net
4MIC_EXTOUT	4HP_L_OUT
5DUMMY net	5GNDA
6HP_DET	6GNDA
7GNDA	7MIC_EXTOUT

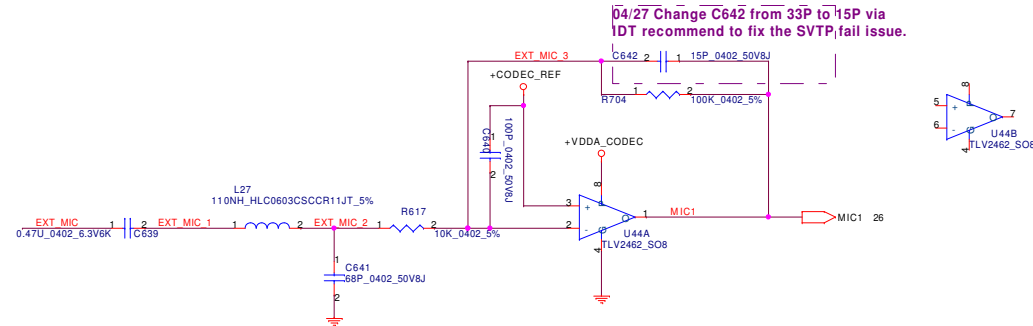
04/27 Change C642 from 33P to 15P via IDT recommend to fix the SVTP fail issue.
